# Repair of a Comminuted Talar Neck Fracture using ViviGen Formable® Cellular Bone Matrix combined with a SymAlign® Cotton Allograft Wedge

Case performed by: Alaa Mansour, DPM, Timothy Howard, DPM;  
Indianapolis, IN, USA

CASE STUDY

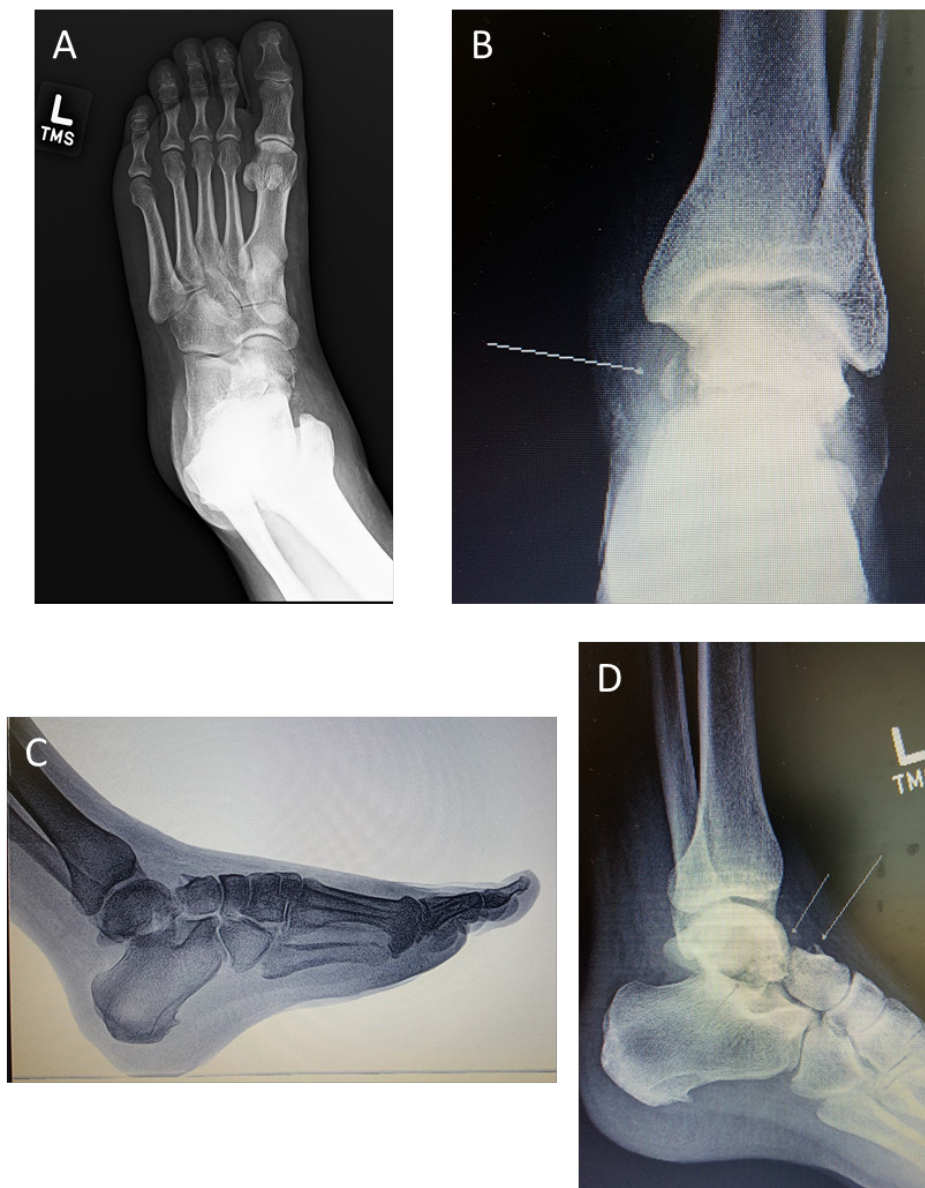
**Figure 1.**

Radiographic imaging of the left foot revealed a talar neck fracture with posterior subtalar joint dislocation. A varus angulation deformity and a 6mm void (white arrow, B) were evident in the medial talar neck (A and B, respectively). Lateral views revealed impingement of the talus against the lateral malleolus (C) and two large bone fragments lodged in the subtalar joint (D, white arrows).

The patient presented with an injury to his left ankle following a fall from a 12-foot ladder. The patient recalls his foot getting trapped in one of the ladder steps and twisting. Radiographic and computed tomography (CT) imaging revealed a talar neck fracture spanning from medial to lateral with significant comminution and dislocation of the posterior subtalar joint (Figures 1 & 2). The medial talar neck was noted to have a 6-mm void as well as a varus angulation deformity secondary to the comminution (Figure 1A and B). Laterally, there was impingement of the talus against the lateral malleolus, and two large fracture pieces lodged in the subtalar joint that were preventing reduction of the dislocation (Figure 1C and D).

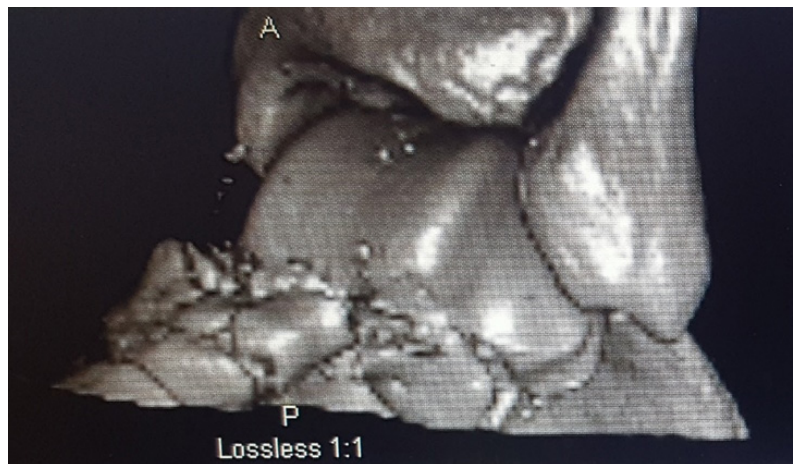
**Figure 2.**

Computed tomography (CT) images revealed significant comminution of the talar neck.
